New York State Department of Transportation

Yellow Flag NB22CTW007

BIN: 1065318

Feature Carried: 278I278IX2M23027

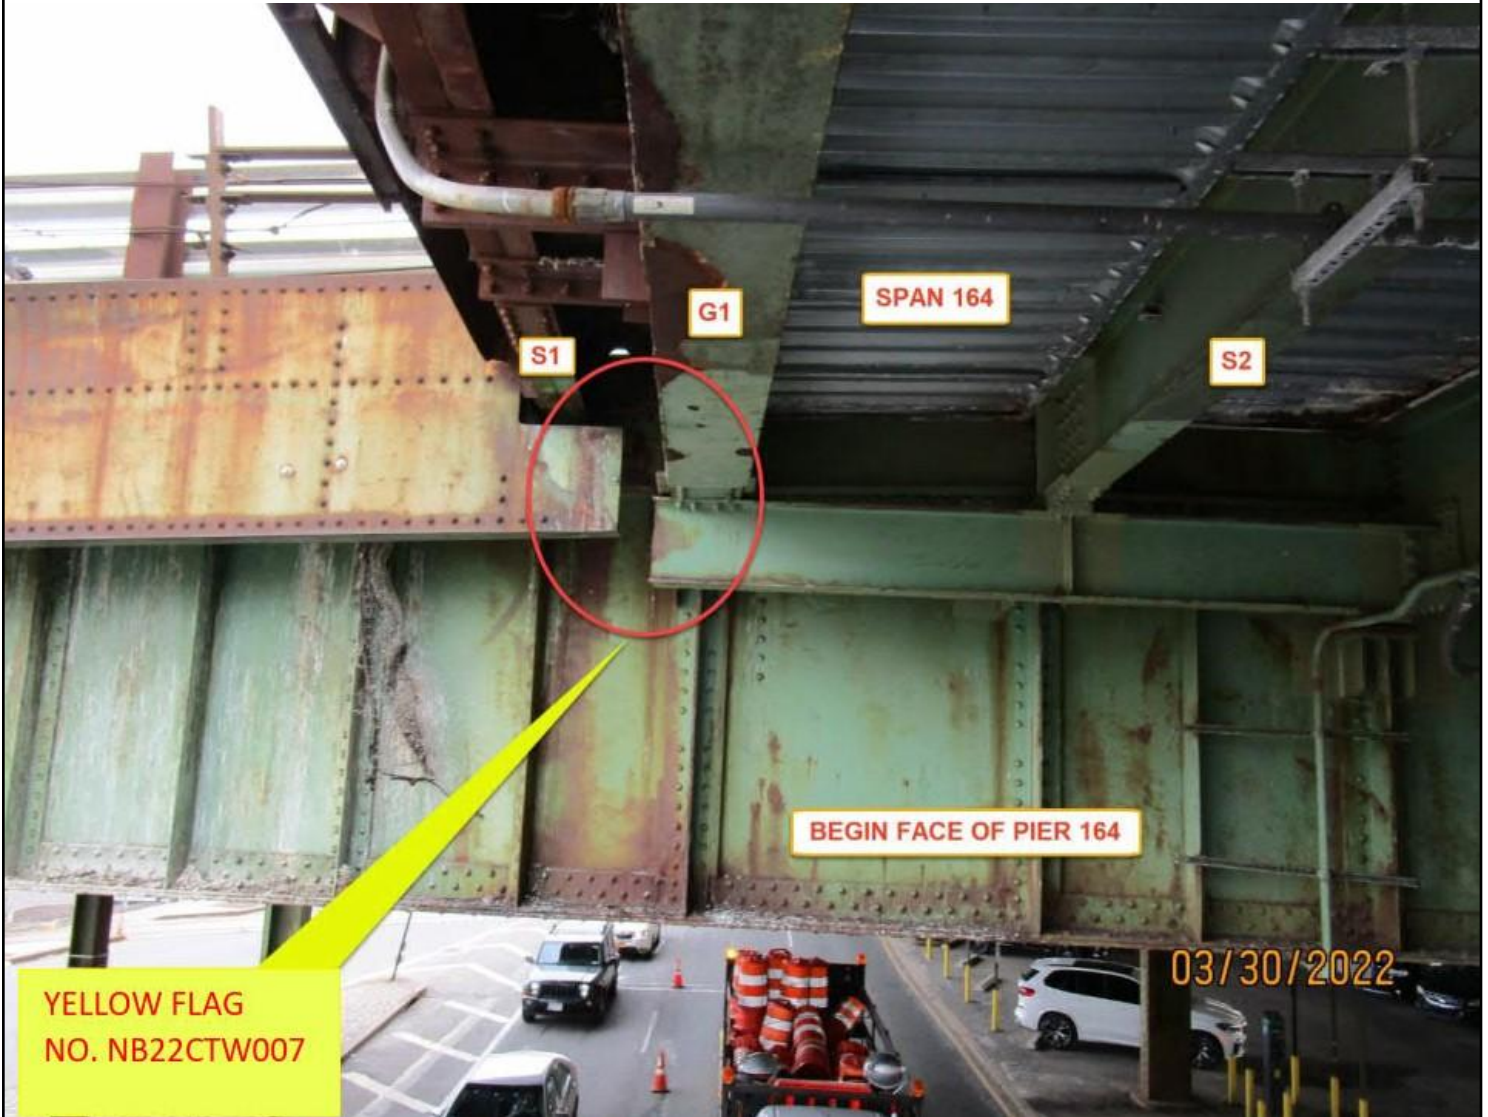
Photo Number: 1

Attachment Description: General view of the flagged condition at the transverse support beam below Stringer S1 in Span 164 at Pier 164. Looking End.

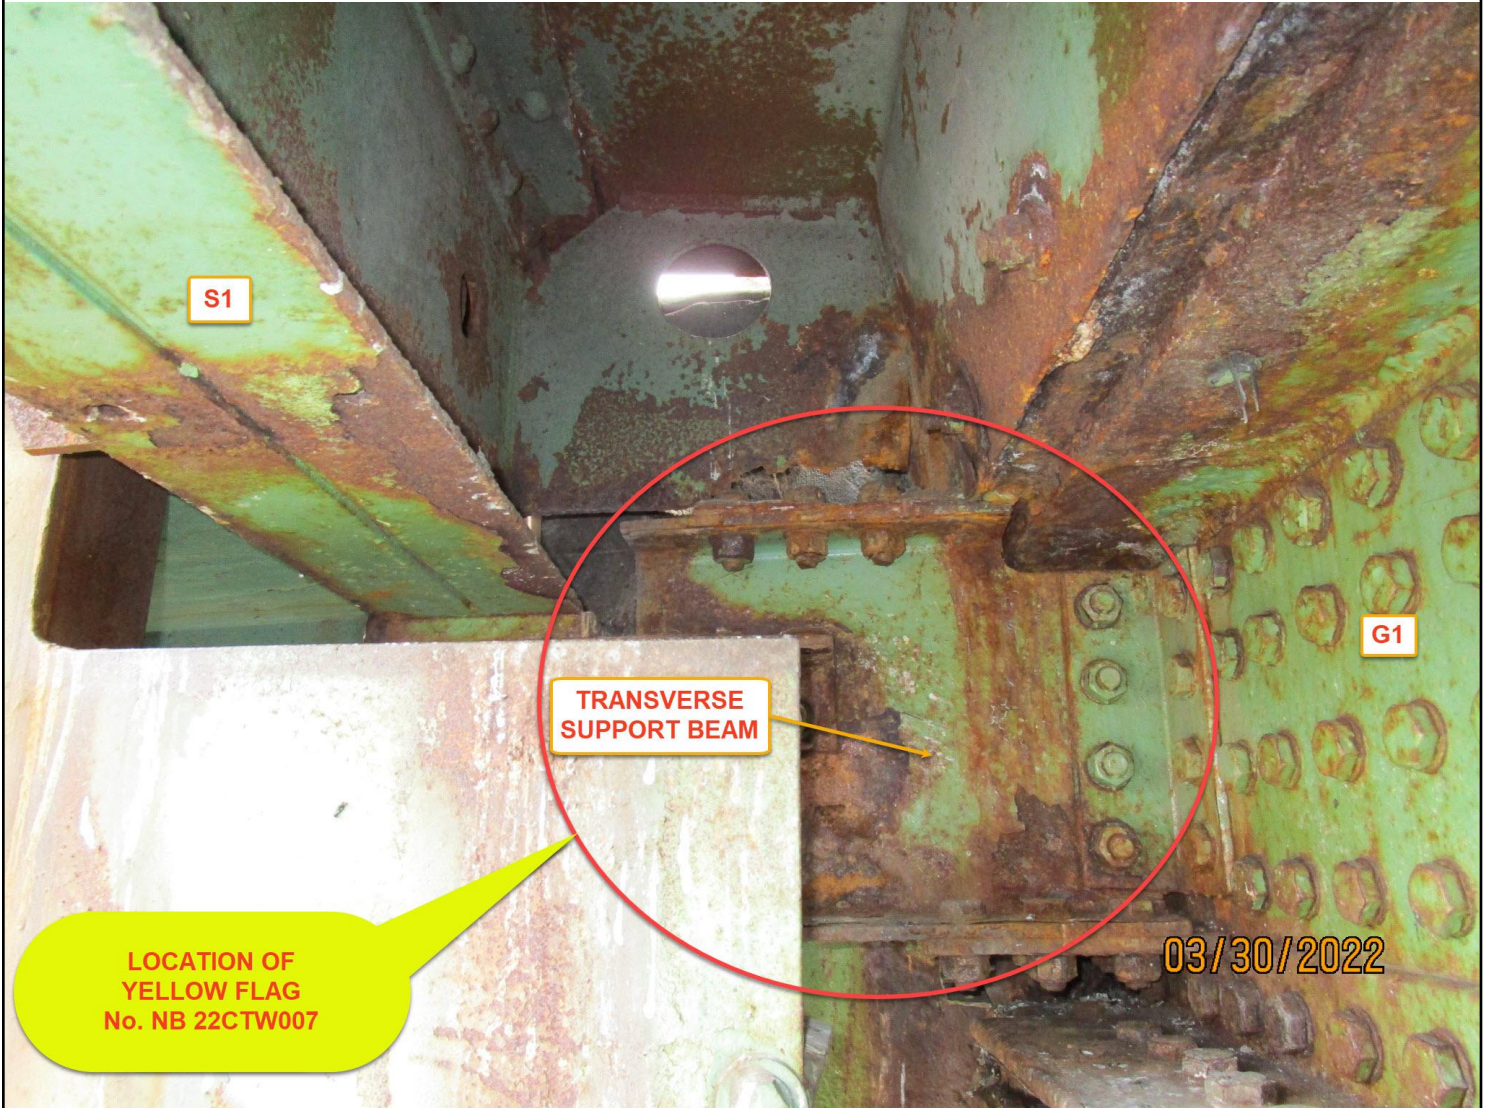
Photo Number: 2

Attachment Description: Close up general view of the flagged condition at the transverse support beam below Stringer S1 in Span 164 at Pier 164. Looking End.

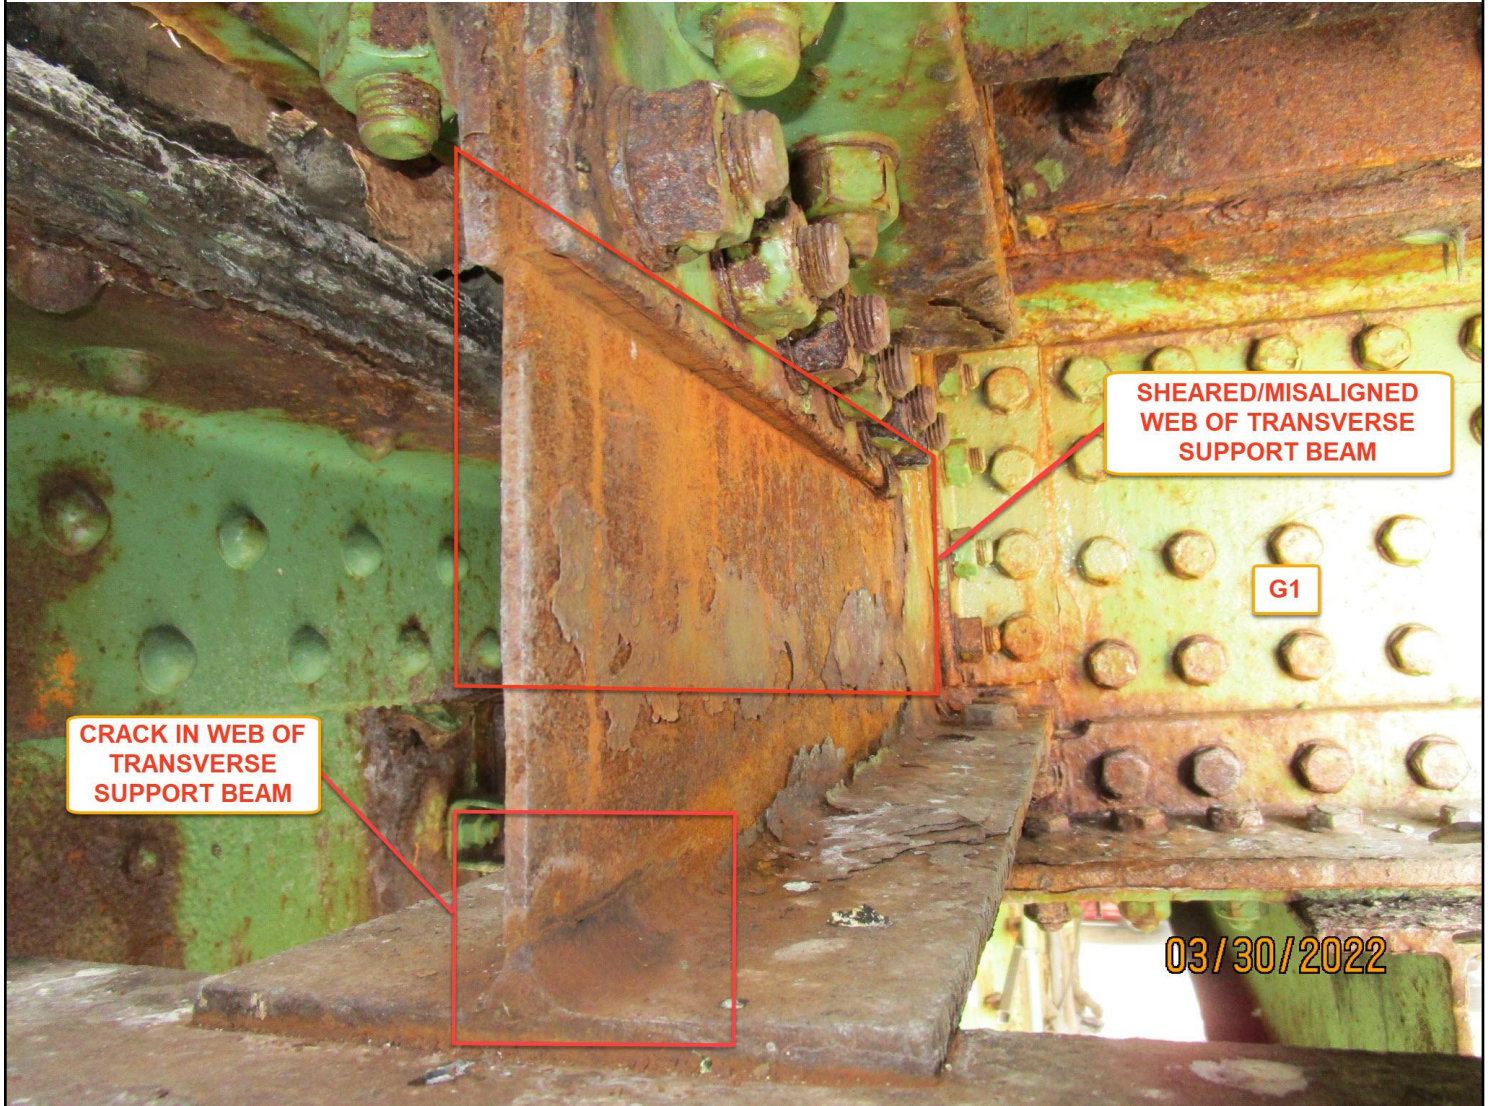
Photo Number: 3

Description: The transverse support beam connected to the left face of Girder G1 supporting the end of Stringer S1 in Span 164 adjacent to Pier 164 exhibits a 4" long crack (no change in condition) in the lower web and 13" long (12" previously noted) sheared/misaligned portion of the upper web (Refer to sketch for details). The sheared/misaligned portion and crack are both located directly below Stringer S1. The crack in the weld is located right above the bottom flange. The sheared/misaligned portion of the web is located right below the top flange angles.

Attachment Description: The begin face of the transverse support beam below Stringer S1 in Span 164 at Pier 164. The stringer web exhibits crack in the lower web and sheared/misaligned portion of the upper web. Looking End and Right.

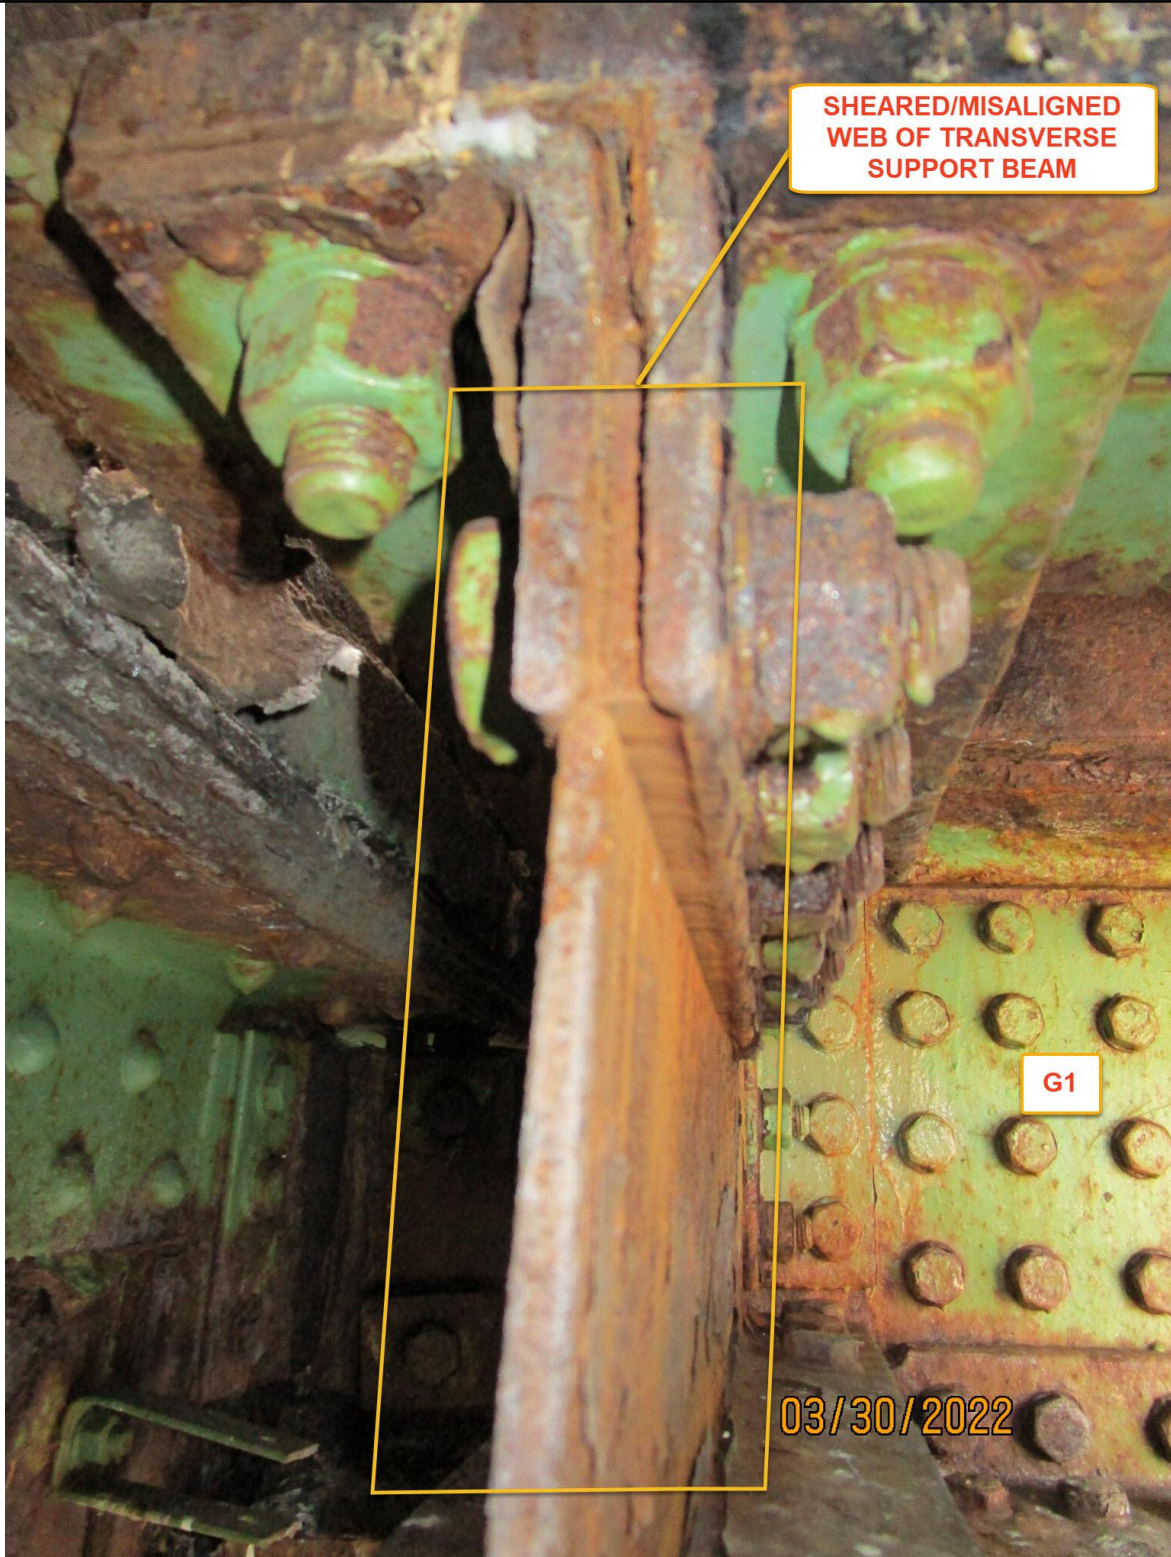
Photo Number: 4

Attachment Description: The left end of the transverse support beam below Stringer S1 in Span 164 at Pier 164. The upper web below the top flange angles exhibit sheared/misaligned portion of the web. Looking Right.

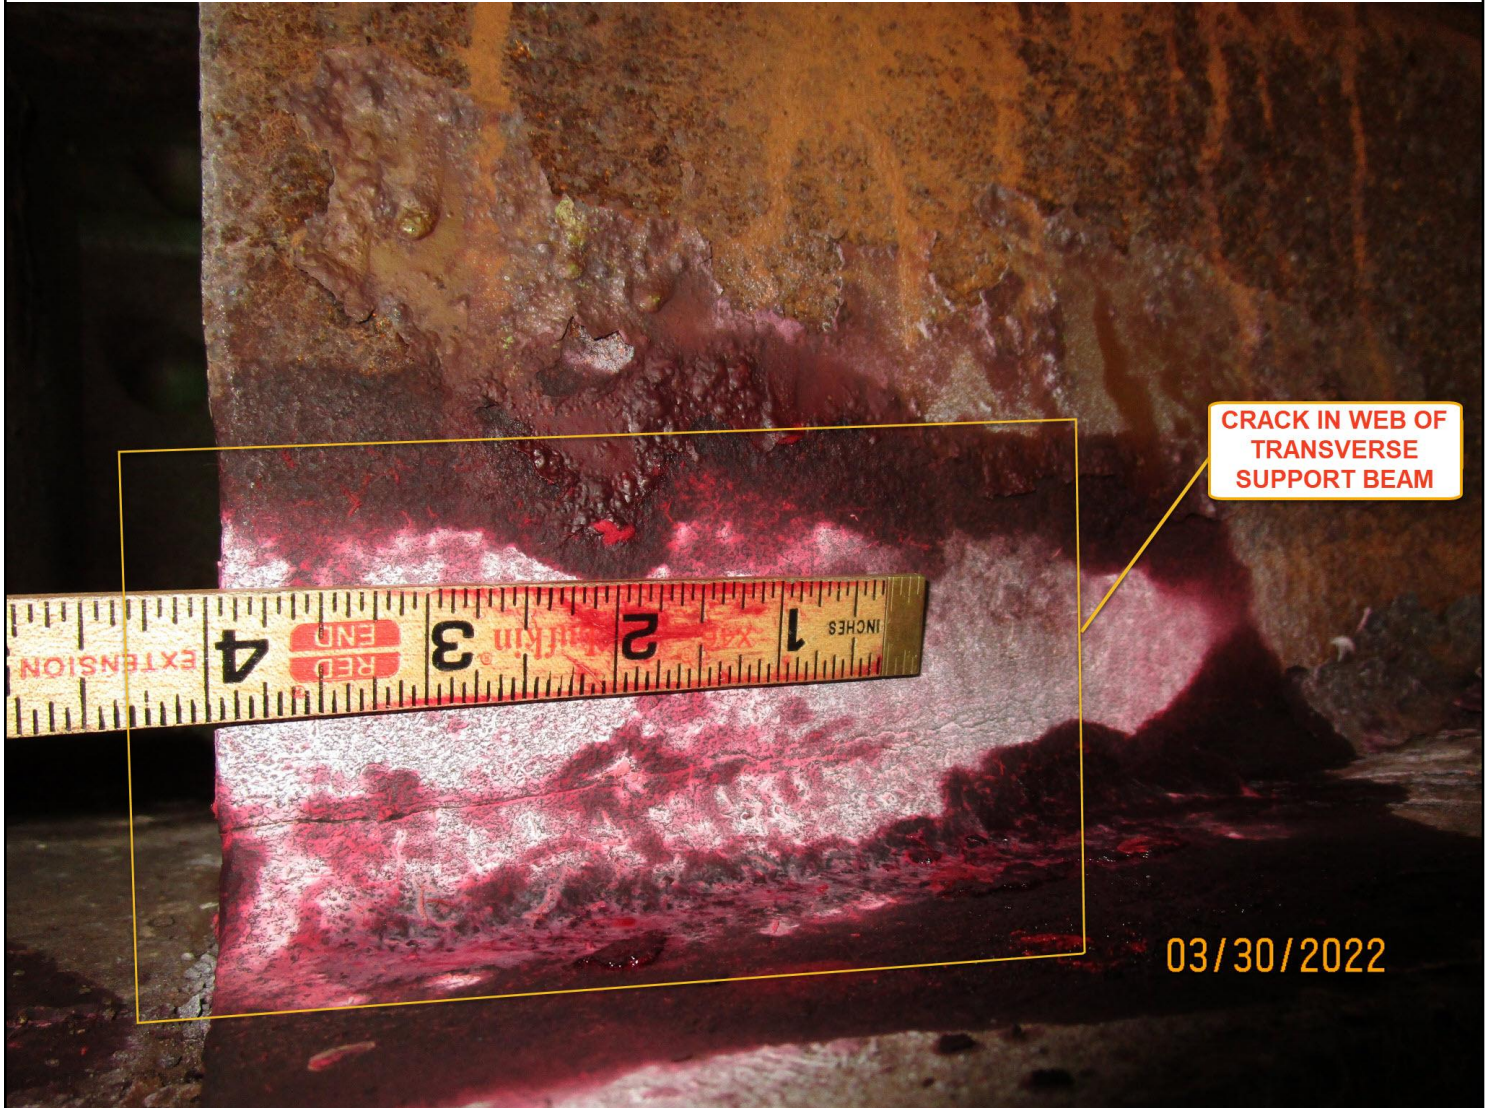
Photo Number: 5

Attachment Description: The bottom portion of the transverse support beam below Stringer S1 in Span 164 at Pier 164. The lower web above the bottom flange exhibits crack in the web. Looking End and Right.

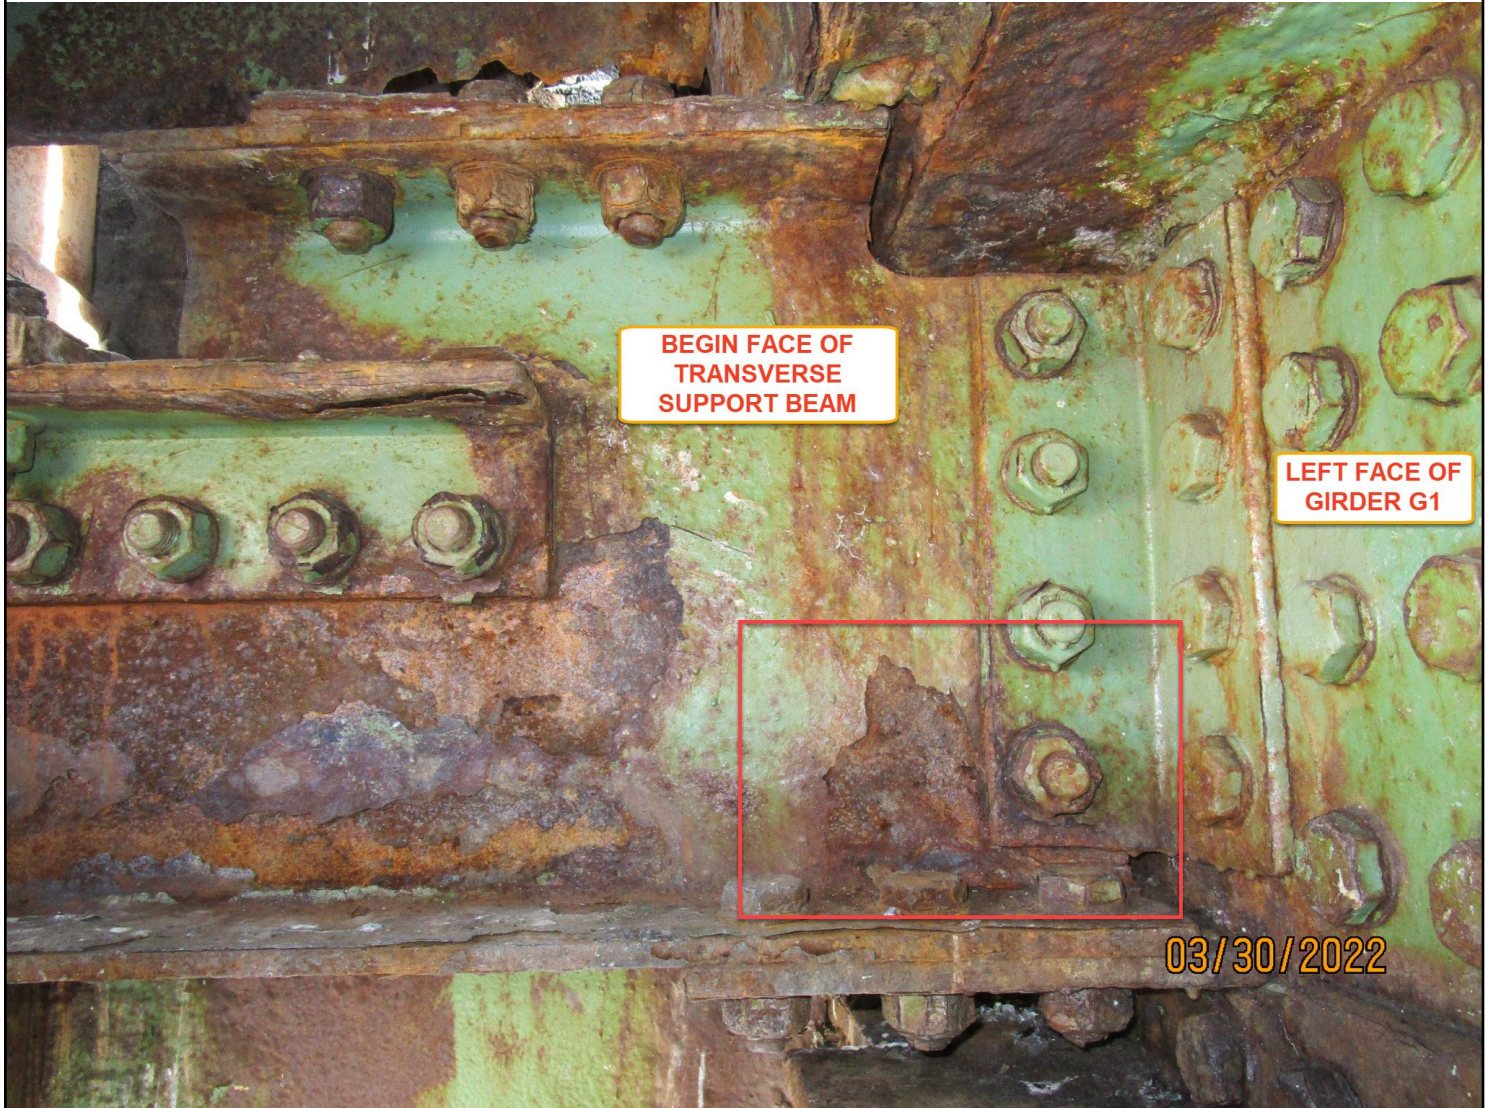
Photo Number: 6

The remaining length of the transverse support beam exhibits moderate corrosion with up to 15% section loss at the lower web adjacent to the connection to Girder G1 (Photo 6). There is no significant change in the condition.

Attachment Description: The begin face of the transverse support beam below Stringer S1 connected to Girder G1 in Span 164 at Pier 164. The remaining length of the transverse support beam exhibits moderate corrosion with section loss. Looking End.

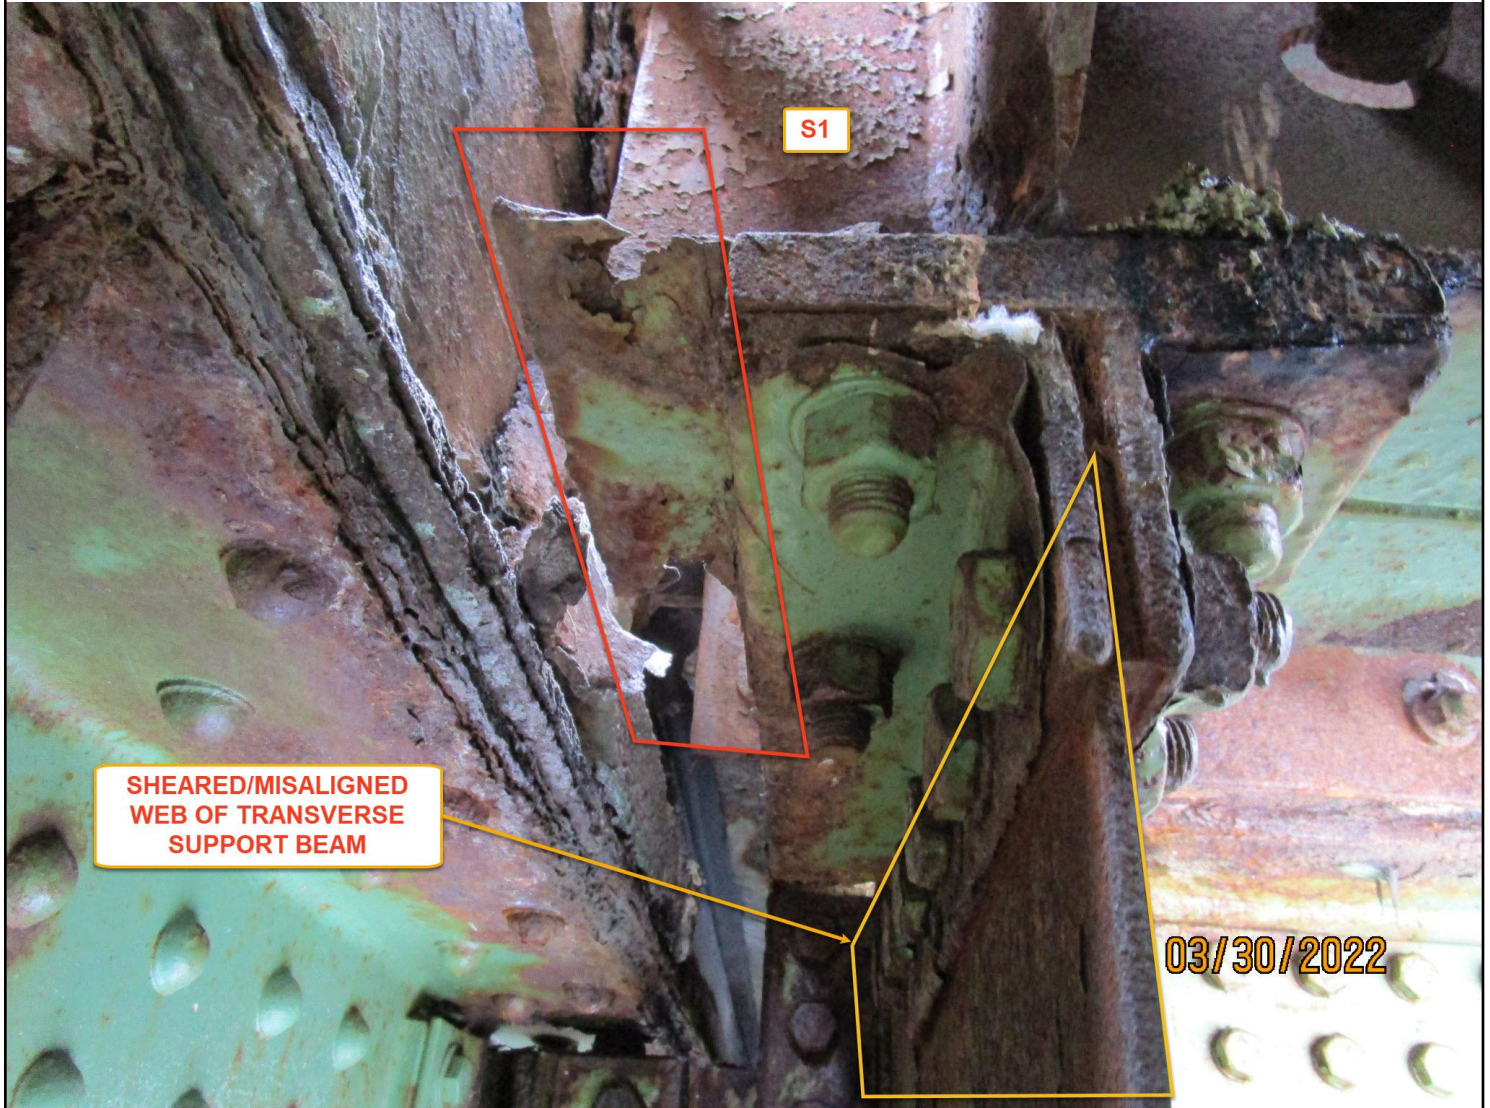
Photo Number: 7

1. The bottom flange of Stringer S1 beyond the bearing area at the transverse support beam exhibits up to 40% section loss for 2" long for the full width of the flange with 1" diameter corrosion hole at each side (Photo 7). The left bearing stiffener exhibits 2" diameter corrosion hole at the bottom of the stiffener. These conditions are the same as reported in the last inspection.
2. The Stringer S1 supports the barrier/railing above on I-278 WB direction.
3. The flagged condition was accessed using 30ft bucket truck with double lane closure.
4. The flagged condition is located above the center lane on 3rd Avenue WB direction.

Attachment Description: The end of Stringer S1 beyond the bearing area at the transverse support beam in Span 164 at Pier 164. The bottom flange exhibits section loss for the full width of the flange with one corrosion hole at each side of the flange. Looking Right.
